Engineering Geology 69 (2003) 1–13

Geological and geomorphological precursors of the Chiu-fen-erh-shan landslide triggered by the Chi-chi earthquake in central Taiwan

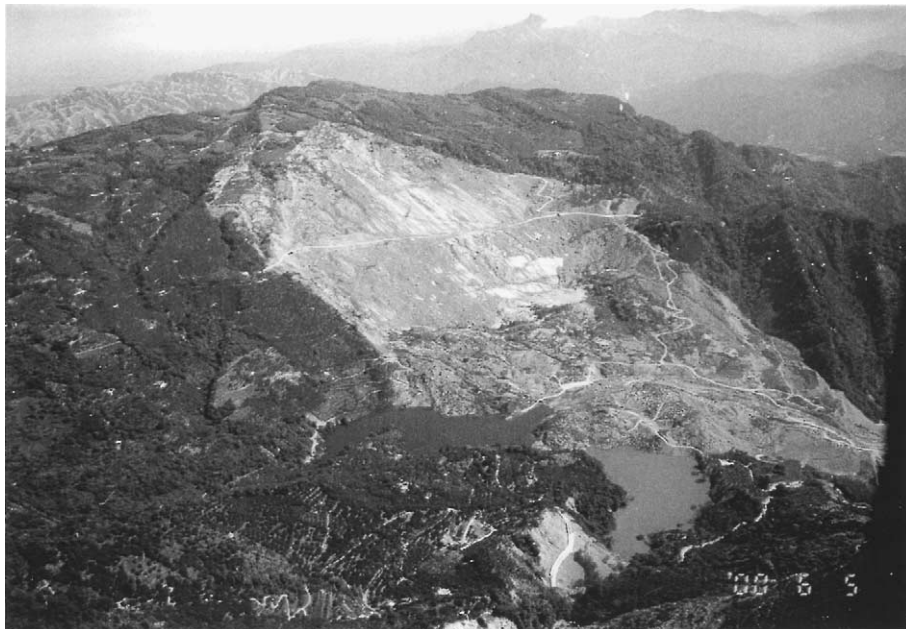
Fig. 1. Overview of the Chiu-fen-erh-shan landslide, looking to the southeast.

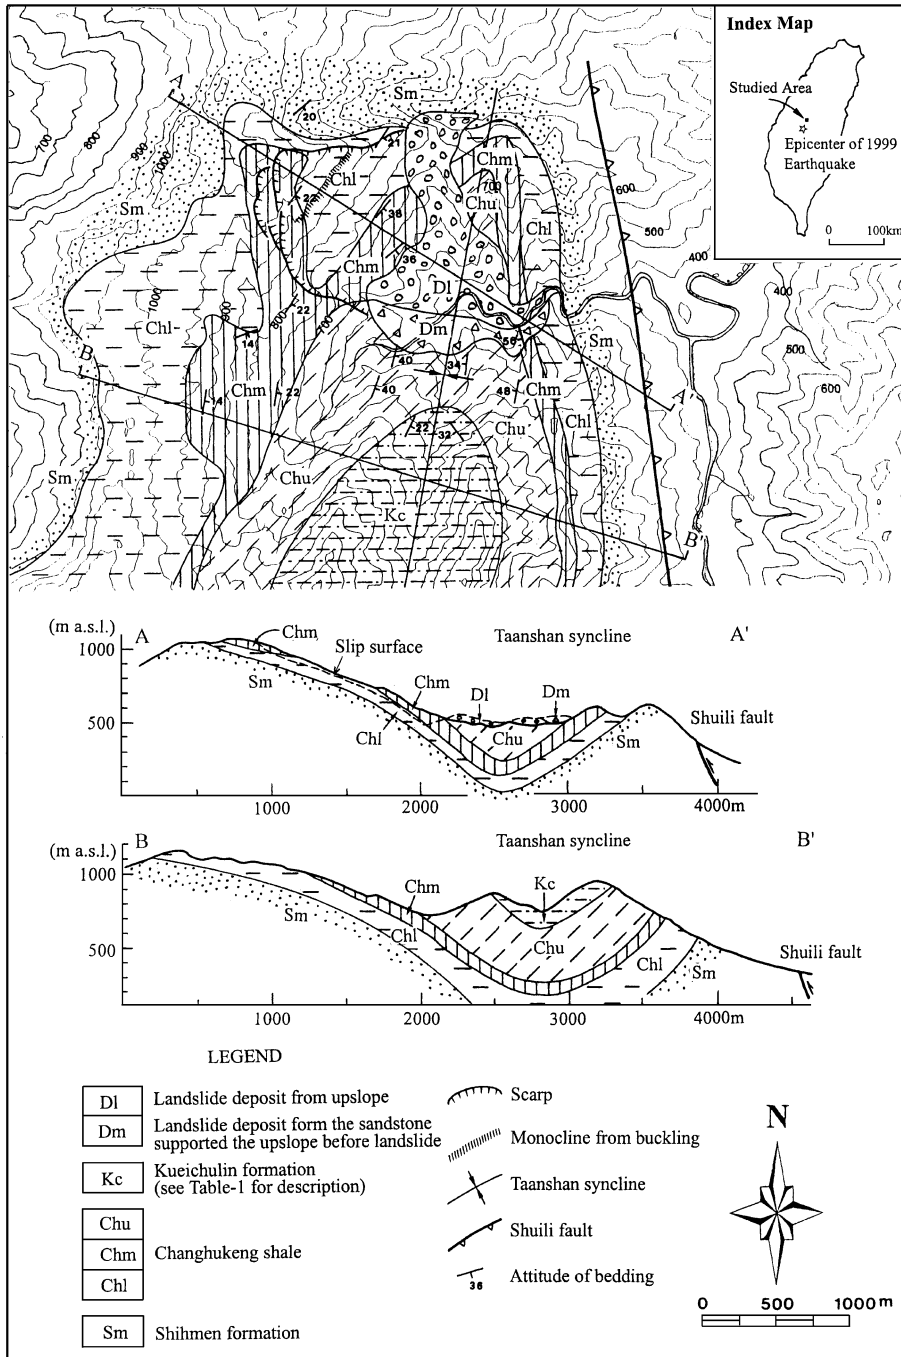
Fig. 3. Geologic map and cross-section of the landslide site.

The study area is located in the inner foothill zone, and is underlain mainly by Miocene sedimentary rocks. The strata exposed in this area are, in ascending order, the Shihmen Formation (Sm), the Changhukeng Shale, and the Kueichulin Formation (Kc) (Ho et al., 1956; Ho and Tan, 1960; Ho, 1986) (Fig. 3; Table 1). The strata are folded with an N–S trending synclinal axis in the eastern part (Fig. 3).

The strata that failed during the Chi-chi earthquake had previously crept, but were supported by a 100-m-thick sandstone bed at the foot of the slope, as shown in the A–A' cross-section of Fig. 3. This was clarified by the detailed geological mapping after the landslide. The sandstone bed has formed resistant protruding ridges at the foot of the slope before the 1999 landslide. This sandstone bed was probably damaged seriously by the Chi-chi earthquake tremor, leading to a catastrophic slide. Similar geological configuration was observed at the Madison slide that occurred in 1959 in the United States (Hadley, 1964, 1978). The upslope of this landslide was composed of schist and gneiss, and the downslope was dolostone, both dipped downslope steeply. Whether creeping occurred or not before sliding is unknown, but the dolostone is inferred to have supported the schist and gneiss upslope. An earthquake ($M=7.1$), whose epicenter was located 20 km from the landslide site, broke the dolostone and triggered a huge landslide, rockslide, and avalanche, for an estimated volume of $21 \times 10^6 \text{ m}^3$. Loss of support from downslope generally leads to a catastrophe like these cases.

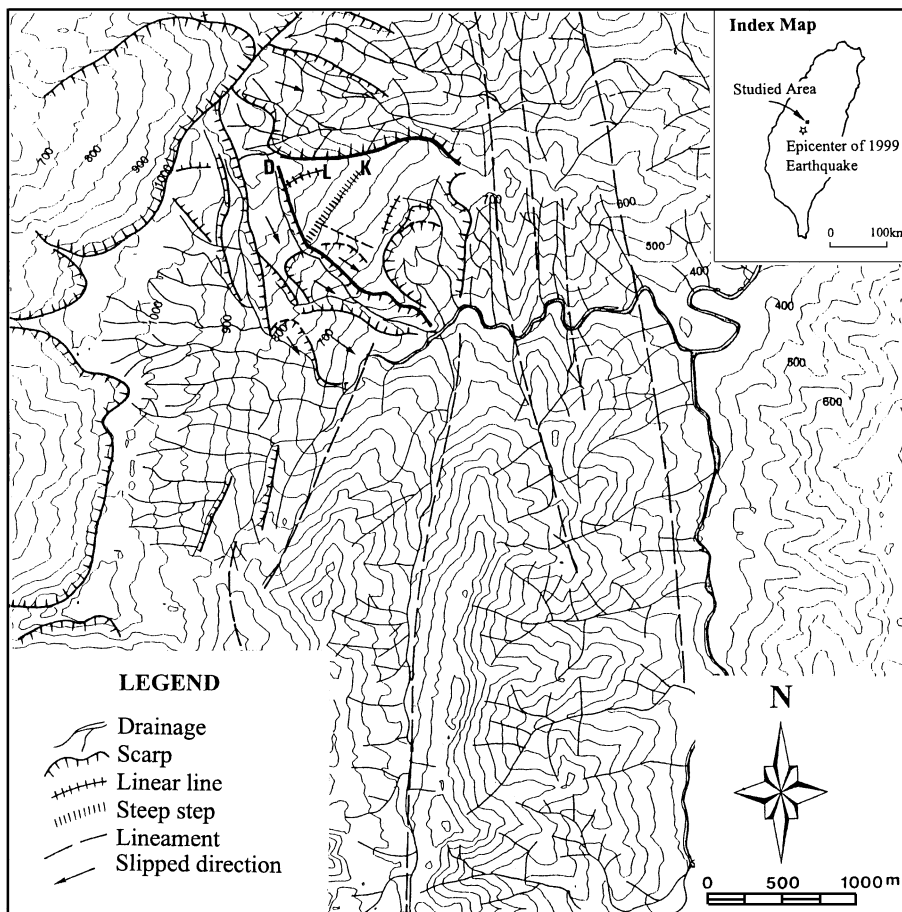
Fig. 4. Geomorphological map before the landslide, mainly based on aerial photo interpretation.

Anomalous features such as a linear depression, a steep step, and low drainage density can be found within the Chu-fen-erh-shan landslide area by examining the aerial photos of 1998 (Fig. 4). The landslide is situated on a dip slope facing SE. The plane view of the dip slope forms an isosceles triangle with northern and southwestern sides bounded by scarps (as indicated by thick lines in Fig. 4). The short linear depression (as indicated by L in Fig. 4), which could be induced by creeping, connects these two sides on the upper part of the dip slope. The steep step (as indicated by K in Fig. 4), trending NE–SW, can be detected from the aerial photos taken in 1998.

The infiltrating rainwater, in turn, was unfavorable to the stability of the slope area. A creek, as indicated by D in Fig. 4, originally provided enough water for living and irrigating a rice field on the middle and low parts of the slid slope before the Chi-chi earthquake. The first author found much flowing water along the slip surface near the trace of this creek 5 days after the 1999 earthquake. The slid slope apparently contained much groundwater unfavorable to its stability.

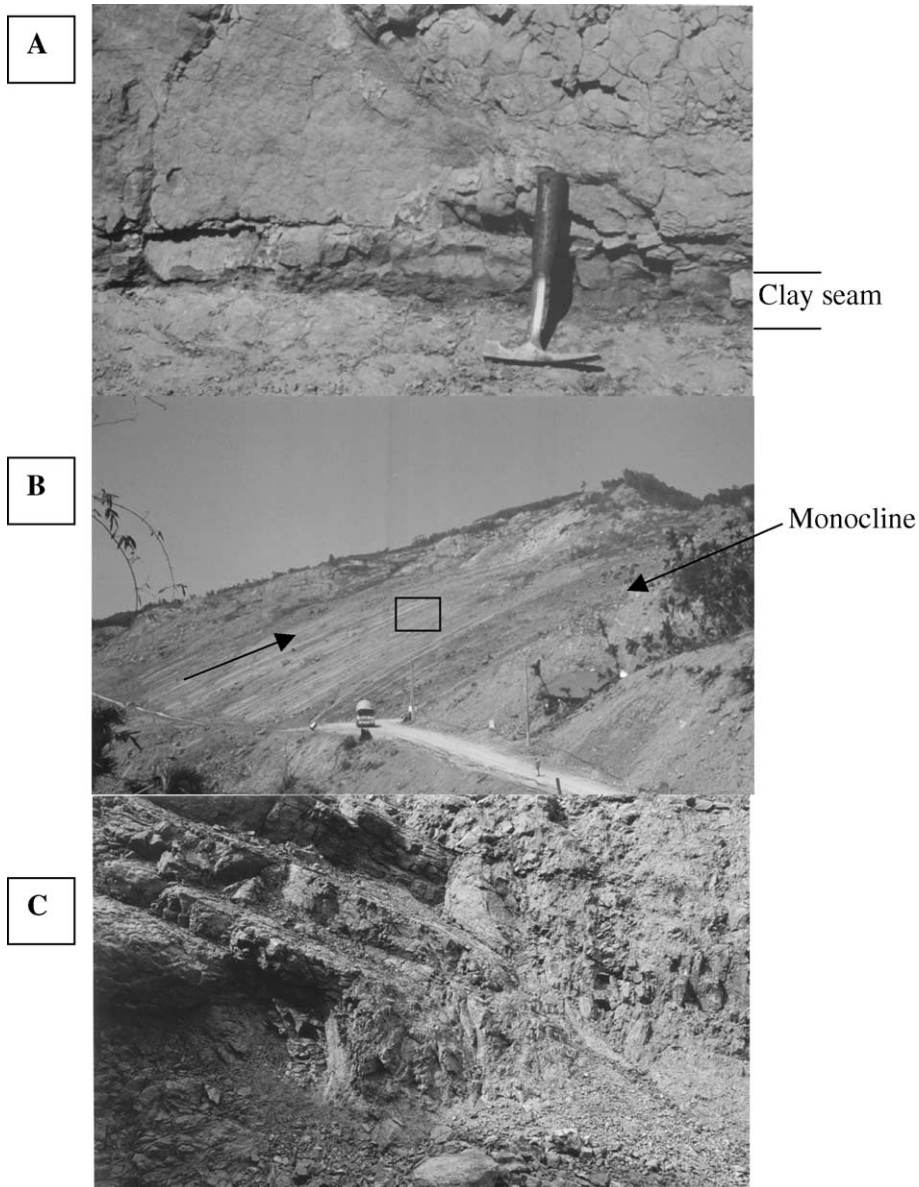
Fig. 6. Geologic features observed in the landslide source area. (A) A clay seam which is inferred to be made by flexural slip during the folding. (B) Upper part of the landslide scar, in which monocline appeared on the slip surface after the landslide. The slip surface becomes steeper downslope. (C) Close up of the box in (B).

A localized monocline, which trends $\text{N}50^\circ\text{--}60^\circ\text{E}$ and extends for 500 m, was found on the upper part of the slope along the slip surface (Figs. 3 and 6B,C). The monocline is a step-like fold in which the upper limb and the lower limb are connected by a steep middle limb. The strata on the upper and the lower limbs dip 20° and 23° , respectively, and the middle limb dips $40\text{--}50^\circ$, forming a 5-m-high step. The hinge of the monocline is relatively smooth and not jagged,

In addition to the monocline described above, small buckling and wedging features were clearly found on the slip surface and the strata beneath it in March 2000 (Figs. 6B,C, 8 and 9). The hinge of the buckling or wedging are up to 10 cm high and have sharp jagged edges, aligned to form a linear feature up to 10 m long. Thrusting with the hanging wall protruding about 50 cm from the slip surface has been found near the toe of the failed slope (Fig. 9C). These small deformational features were formed after the 1999 landslide, as evidenced by their angular edges.

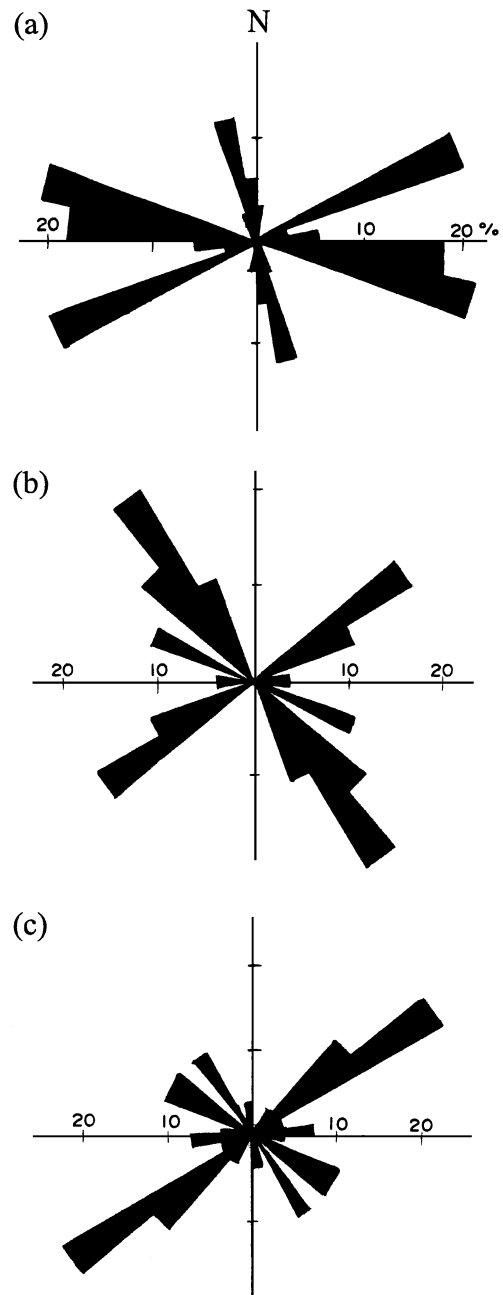
Fig. 7. Rose diagram showing joint systems measured (a) upslope from, (b) at, and (c) downslope from the monocline.

landslide (Figs. 3 and 4), the steep step is obviously the surface expression of the subsurface deformation that made the monocline (Figs. 3 and 4). Evolution of the monoclinical deformation is depicted in joint orientation and joint filling. Most joints measured on the slip surface strike $N50^{\circ}-70^{\circ}E$, nearly perpendicular to slip direction, as shown in Fig. 7. But the middle limb of the monocline described above has one more set of joint that is prevalent in $N30^{\circ}-40^{\circ}W$, parallel to the slip direction. The joints parallel to the slip direction may have resulted from a gravitational stress, which was unrelated to the earlier folding episode. The nearly EW-striking joints on the slope are often calcite-filled, showing that they were formed from a tectonic stress rather than a gravitational stress. The NW-trending joints are scarcely filled with calcite.

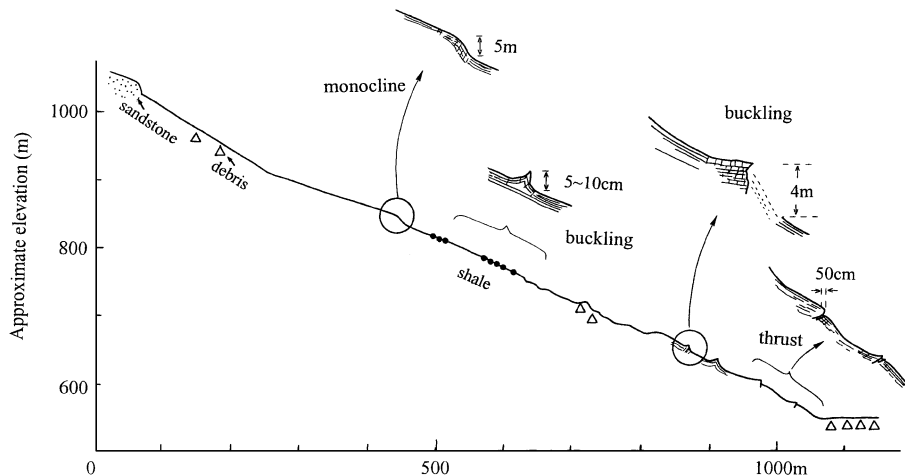
Fig. 8. Measured profile of the Chiu-fen-erh-shan landslide with various features from the buckling of strata.

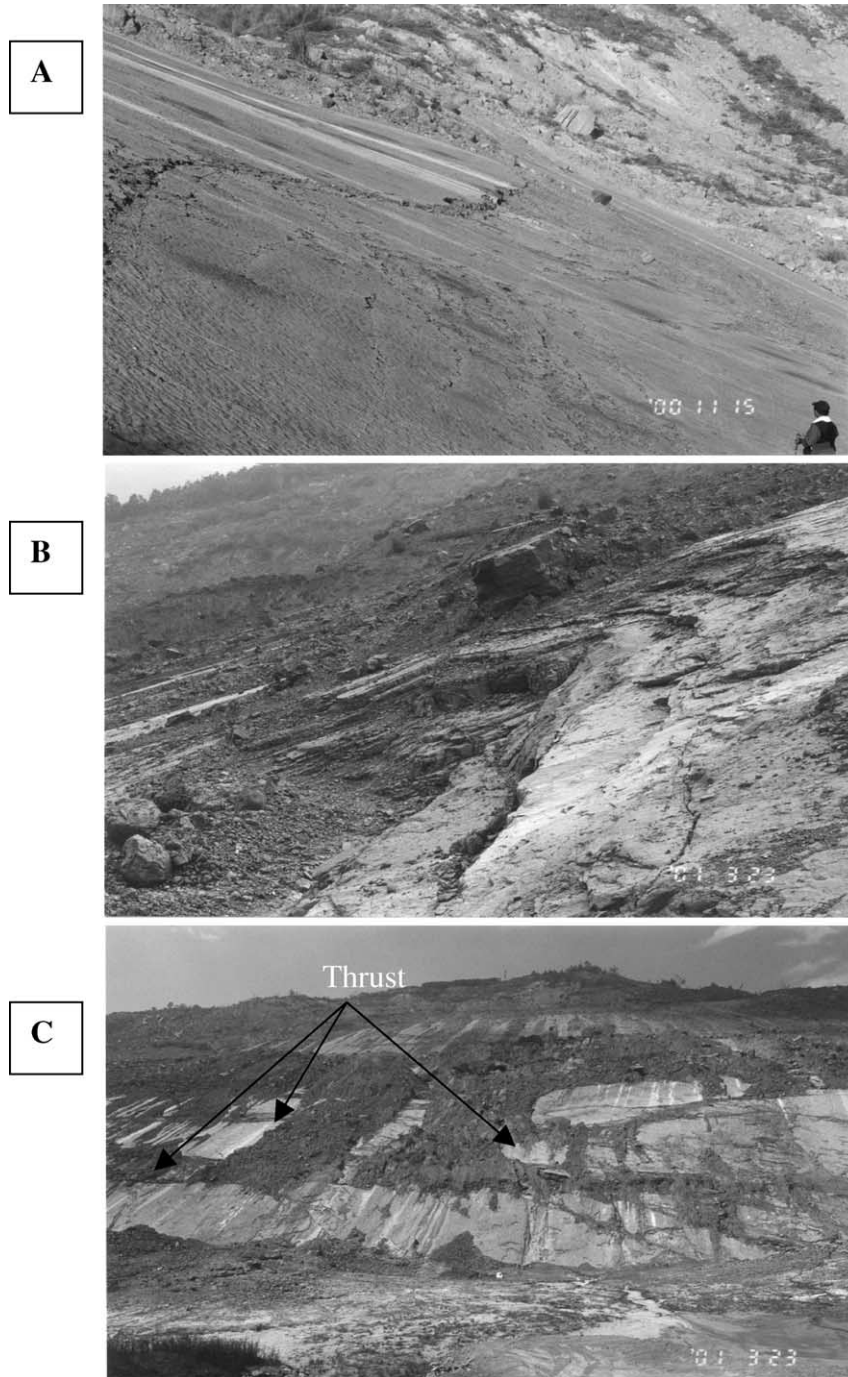
Fig. 9. Deformed features after the 1999 landslide. (A) Large buckling of alternated beds of sandstone and shale with ripples. (B) Small buckling of the strata. (C) Thrust faults in the lower part of the landslide area.

Buckling, wedging, and thrusting similar to those proposed by Hutchinson (1987) occurred more densely in the lower part of the slope than the upper part (Fig. 9) after the 1999 landslide. This is due to the following

three factors. Firstly, the bedding-parallel clay seams are present throughout the slope. Secondly, the slope inclination becomes steeper downslope. Finally, the sandstone bed supporting the unstable strata was removed during the 1999 landslide. As indicated by these deformations, the lower part of the slope of the Chiu-fen-erh-shan landslide is currently still creeping, and therefore, susceptible to further sliding. Catastrophic landslide disasters will recur because the failure of the lower slope destabilizes the upper slope.
