Geological and geomorphological characteristics of landslides triggered by the 2004 Mid Niigata prefecture earthquake in Japan

Masahiro Chigira^{a,*}, Hiroshi Yagi^b

^a Disaster Prevention Research Institute, Kyoto University Gokasho, Uji 611-0011, Japan

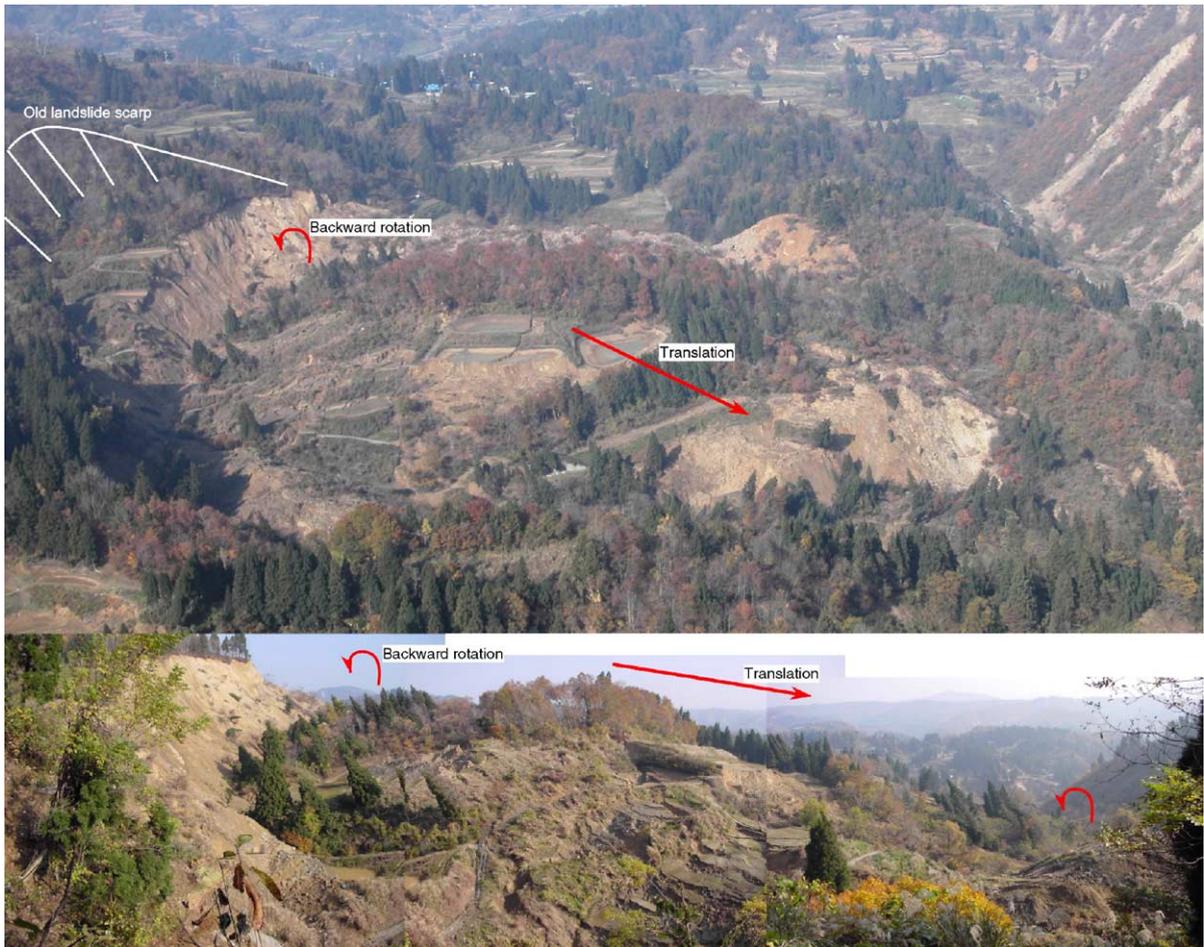
Fig. 10. Shiotani slide. Above: overview; below: side-looking view. The arrows indicate rotational and translational movements.

but did not rotate in the middle, judging from the tree attitudes (Fig. 10). The toe of the slide overrode the opposite slope and rotated 25° backward. These ground surface attitudes indicate that the slip surface in the middle and lower part of the slope was planar and parallel to the bedding plane, and listric upslope. The strata above the listric slip surface rotated backward, forming a “roll-over” antiform in a manner similar to that shown by Ramsay and Huber (1987) {Ramsay, 1987 #58} {Ramsay, 1987 #58} {Ramsay, 1987 #58} {Ramsay, 1987 #58}. The bedding plane exposed at the landslide scar dipped 20° to the west, which was the result of the backward rotation of the previous landslide.

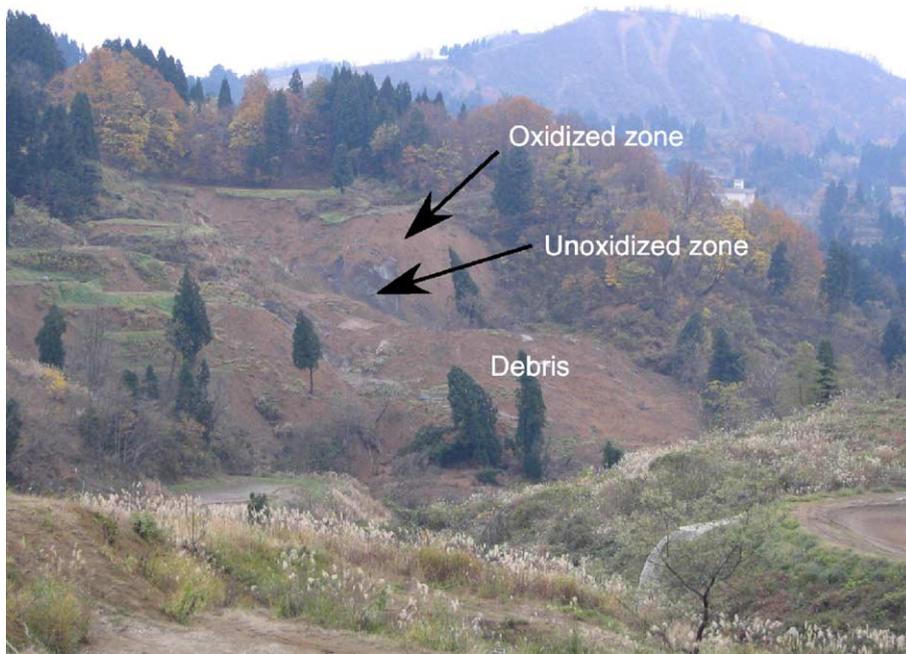
Fig. 11. Aburao slide (Number 13 in Fig. 2). Black mudstone can be seen in the middle and lower part of the landslide scarp.

Pliocene Araya Formation (Fig. 2); many of them were oxidized mudstone slides, exposing unoxidized black mudstone on their landslide scars (Fig. 11). The surface morphology of many of the landslides occurring in the mudstone area showed ductile deformation with fewer large open cracks; this is probably due to the weakness of the weathered (oxidized) mudstone. The black mudstone exposed in the scars was just beneath the oxidation front, and was probably the dissolved and deteriorated zone reported by Chigira (1990). This indicates that the sliding surfaces were made along or beneath the oxidation front, which is common for landslides induced by artificial excavation (Chigira, 1990). The landslides listed in Table 2 include the Aburao, Tanesuhara, and Mitsumine landslides, all of which seem to have been undercut by erosion before the earthquake, based on the examination of aerial photographs. The sliding surfaces of this type of landslide

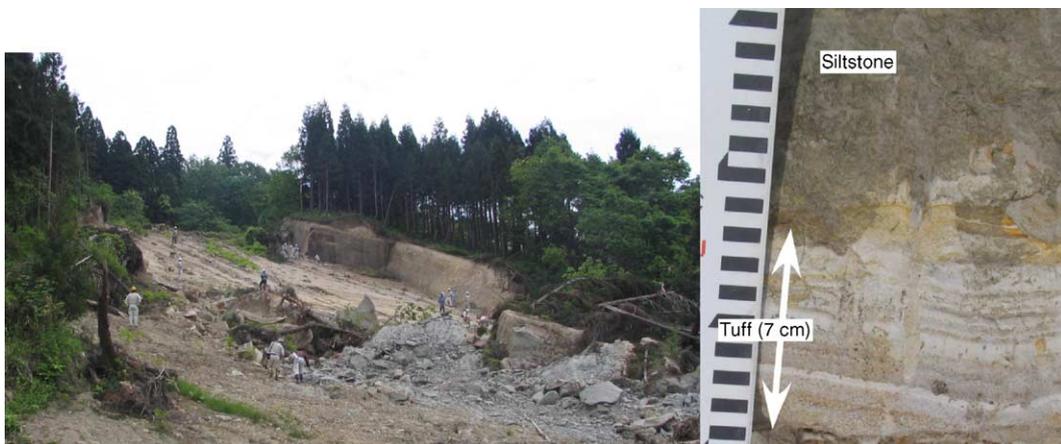
Fig. 12. Rockslide near Shiraiwa, showing very planar sliding surface (left) and a tuff bed in which the sliding surface was made (right). Northernmost landslide in Fig. 13. Water was filtrating out of this tuff bed.

This type of rockslide occurred in more than two locations along the western margin of the Higashiyama Hills. Figs. 12 and 13 show the photographs, geologic
