Geomorphology 46 (2002) 117–128

Geologic factors contributing to landslide generation in a pyroclastic area: August 1998 Nishigo Village, Japan

Masahiro Chigira*

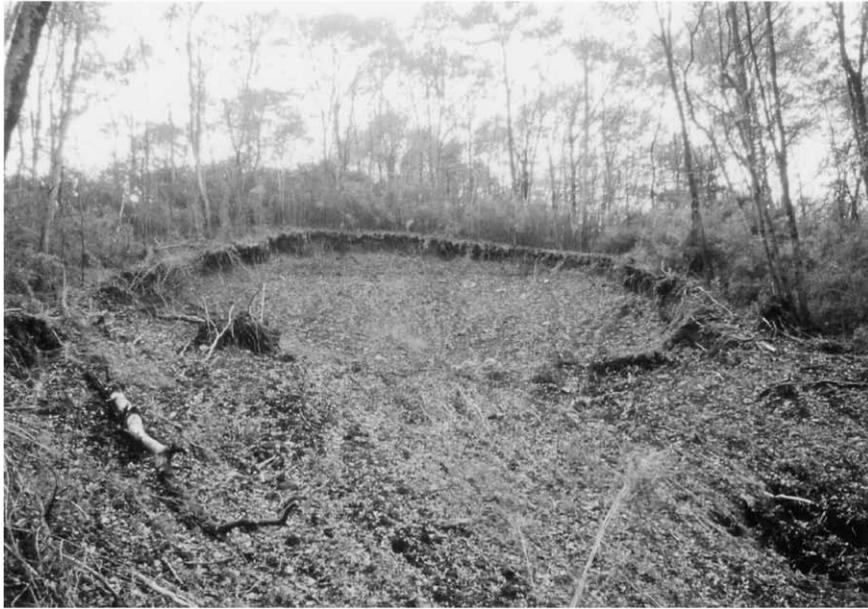
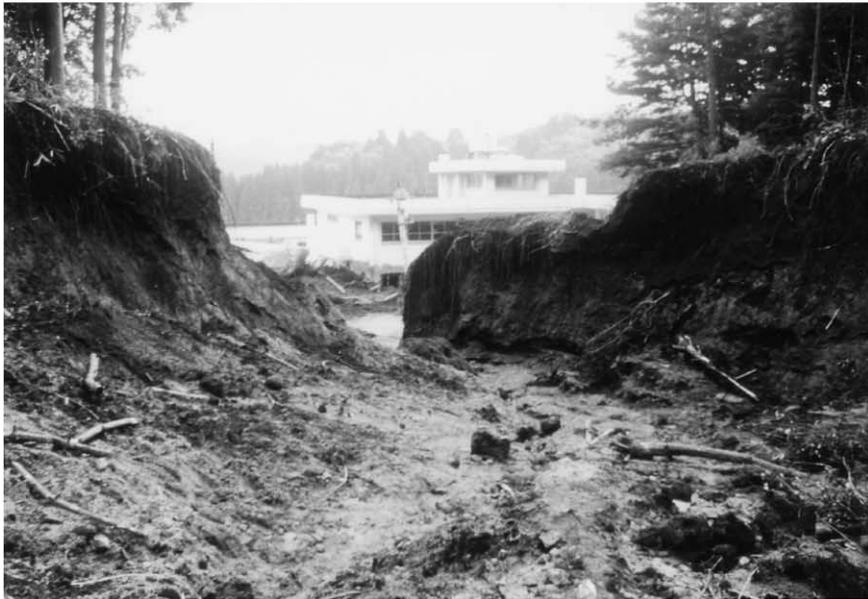
Fig. 6. Typical types of landslide. (A) Landslide of pyroclastic fall deposits overlying mudflow deposits and weakly welded tuff. The landslide scar is an amphitheater-like depression with a diameter of 10 m. Debris came down to the front, but no debris remains, flattened grasses are observable: photo taken 2 months after the event. (B) Landslide of colluvium and ash that filled a former stream near the Daishin Junior High School 15 km northeast of Taiyo-no Kuni. The previous ground surface smoothly connected the left and right top surfaces in the photo. The debris rushed into the building of the Junior High School (middle of the photograph).

The scar of this type of landslide is a spoon-shaped depression, in which almost no debris remains (Fig. 6A). In the upper parts of the scars, pyroclastic fall deposits were exposed and many piping holes were generally present in soft ash. In some locations, groundwater was still observed discharging from the porous scoria 1 week after the event of August 1998. At the base of the scars, impermeable mudflow deposits

and only flattened them onto the ground surfaces along its path (Fig. 6A).

Failure of colluvium or ash that filled depressions was also triggered by the intense rainfall, although this type of failure seemed less common than the other two types. A typical example of this was a landslide that occurred near Daishin Junior High School, 15 km northeast of Taiyo-no Kuni, where a former buried stream was exposed again by the landslide, leaving a scar 5 m deep and 80 m long (Fig. 6B). On the bed of the landslide scar, ignimbrite was observed to be overlain by horizontal beds of silt and sand, which in turn were overlain by ash. This landslide occurred as a result of subsurface erosion caused by the groundwater infiltrating the superficial beds above the impermeable tuff. Landslides of this type generally had piping holes around the tops of the landslide scars, which had a maximum size of 1 m in diameter.

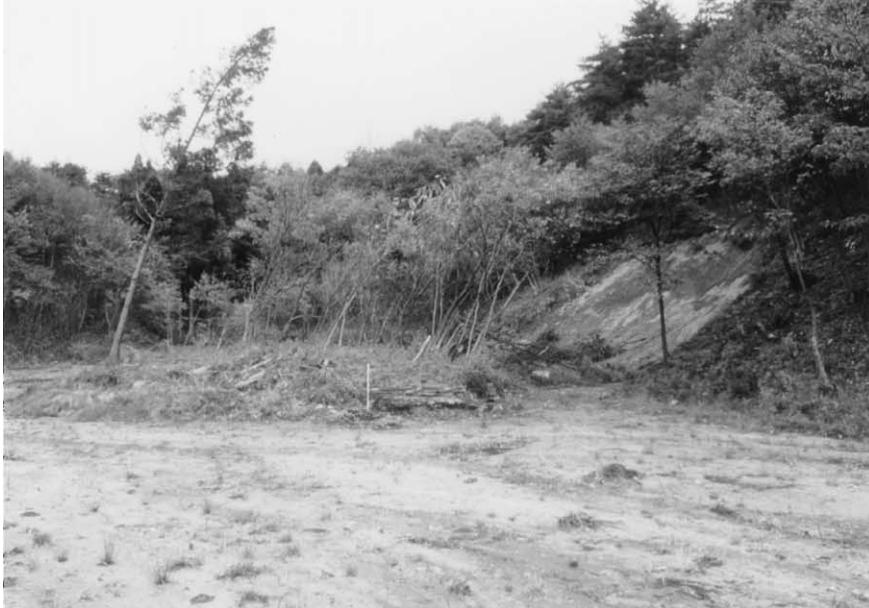
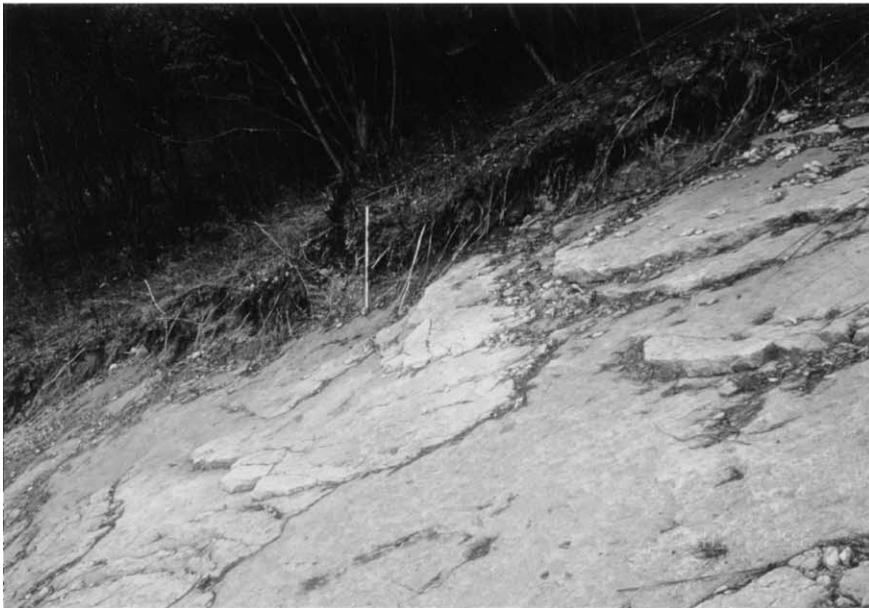
Fig. 7. Landslide of colluvium and weathered tuff with its sliding surface on the heavily weathered tuff. (A) Landslide on a 35° slope with its lobate deposit on flat ground. The scale is 1 m. (B) Sliding surface under which tuff is exfoliated with fractures parallel to the ground surface.

Many landslides had scars that were easily identified by their bright color, a result of the exposed tuff (Fig. 7A). These landslides are less than a few meters deep and involve the failure of weathered tuff and/or

have their sliding surfaces in this exfoliated zone, thus leaving some plates of tuff beneath the landslide scars (Fig. 7B). The mineralogical and chemical characteristics of the weathering profile are described in a separate paper (Chigira et al., in press).
