Engineering Geology 69 (2003) 1–13

Geological and geomorphological precursors of the Chiu-fen-erh-shan landslide triggered by the Chi-chi earthquake in central Taiwan

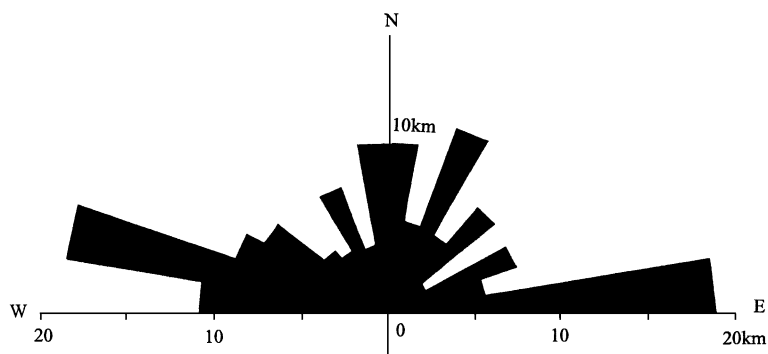
Fig. 5. Accumulated length of drainage ways according to the drainage direction.

length with respect to drainage direction (Fig. 5). The EW-trending drainage ways are notably perpendicular to the axis of the Taanshan syncline.
